IDEA 3.6.103 Readme File

README for Foresight Imaging IDEA V3.6.103, January 6, 2025
This release is provided as an online download for Windows 10 & 11
64 bit operating systems.

IDEA v3.6.103 for 64 bit OS

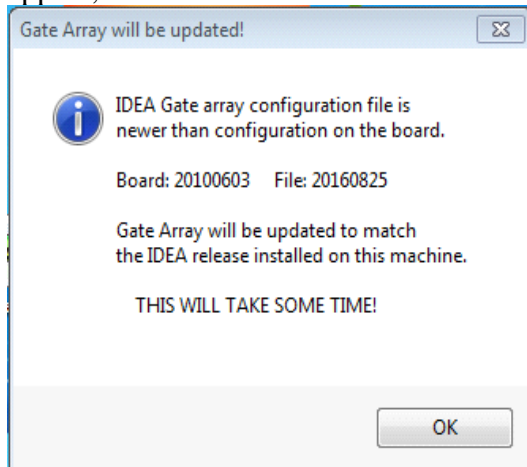
-Upon invoking an IDEA application, an “**IDEA Gate array configuration**” message may appear, similar to:

This is not an error message, but an indication the programmed firmware on the AccuStream board is not the same version as the files in IDEA software.

The revision is in a date format of **YYYYMMDD**.

The recommended action is to update the board to the newest Gate Array firmware file by selecting: OK, and following the prompts.

The recommended action is to update the IDEA software to the newest revision. Or, if not practical / feasible to update IDEA software revision, to eliminate the mismatch Gate array message, replace the existing older gate array firmware files, with the latest IDEA files.

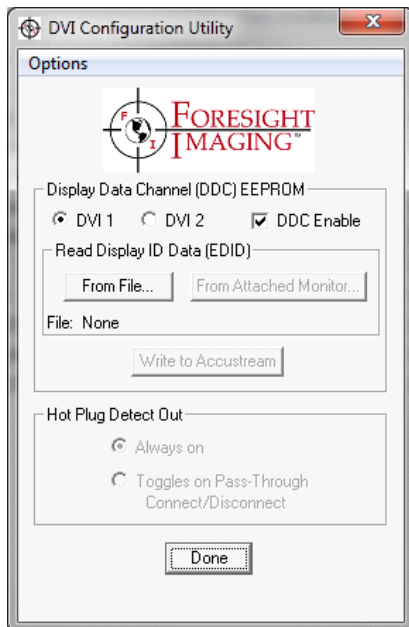
-Select "FROM FILE",

-Choose the desired default native resolution from the selections.
